**A METHOD FOR THE SURFACE  
INSTALLATION AND FAIRING OF  
STATIC-PRESSURE ORIFICES ON A  
LARGE SUPERSONIC-CRUISE AIRPLANE**

*by Norman V. Taillon*

*Flight Research Center  
Edwards, Calif.*

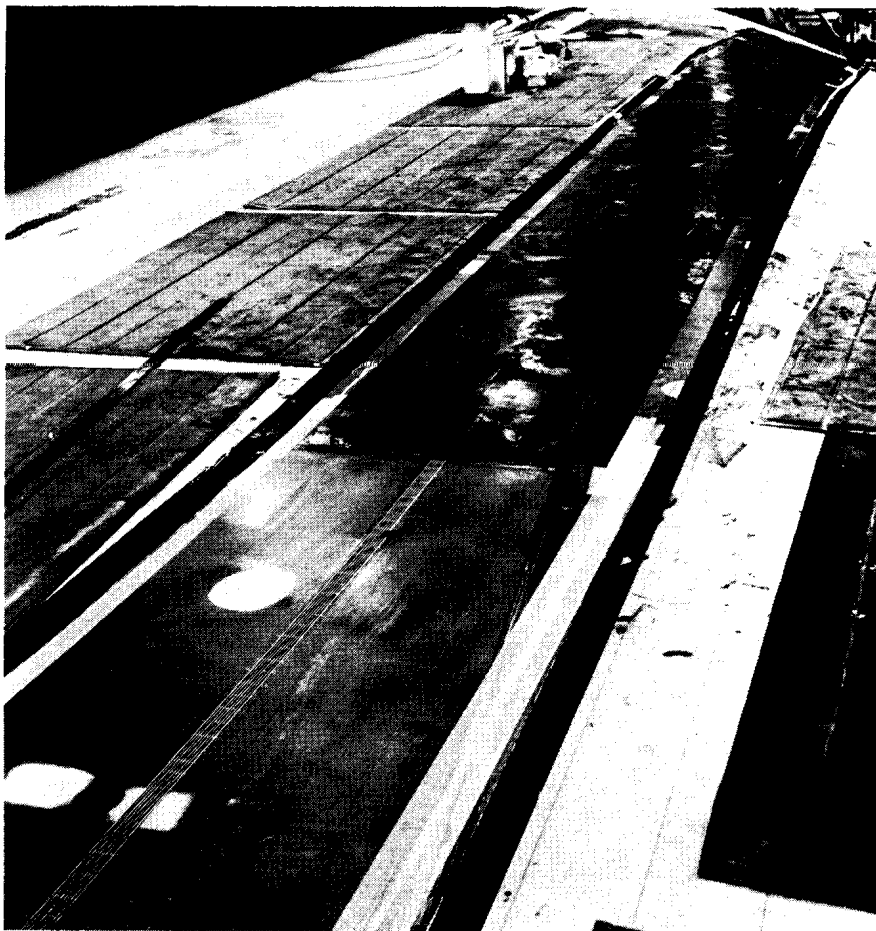
Figure 7.— Partially covered tubing.

Application. — Preparation of the tubing and sanded metal surface for application of the fairing compound consisted of an initial wiping with methyl ethyl ketone followed by a thorough cleaning with trichloroethane. Both tubing and surface were then sprayed with a light coating of a silicone primer compatible with the RTV. Red Thunder was catalyzed in batches of 1000 grams and troweled on the surface and tubing, beginning at the leading edge. The covering was applied in a band about 30 inches (76.2 centimeters) wide, with a crown centered on the orifice row and tapering out to a feather edge at each side (fig. 7). A 1000-gram batch covered about 18 inches (45.72 centimeters) in the chordwise direction. Curing time was approximately 1 hour.

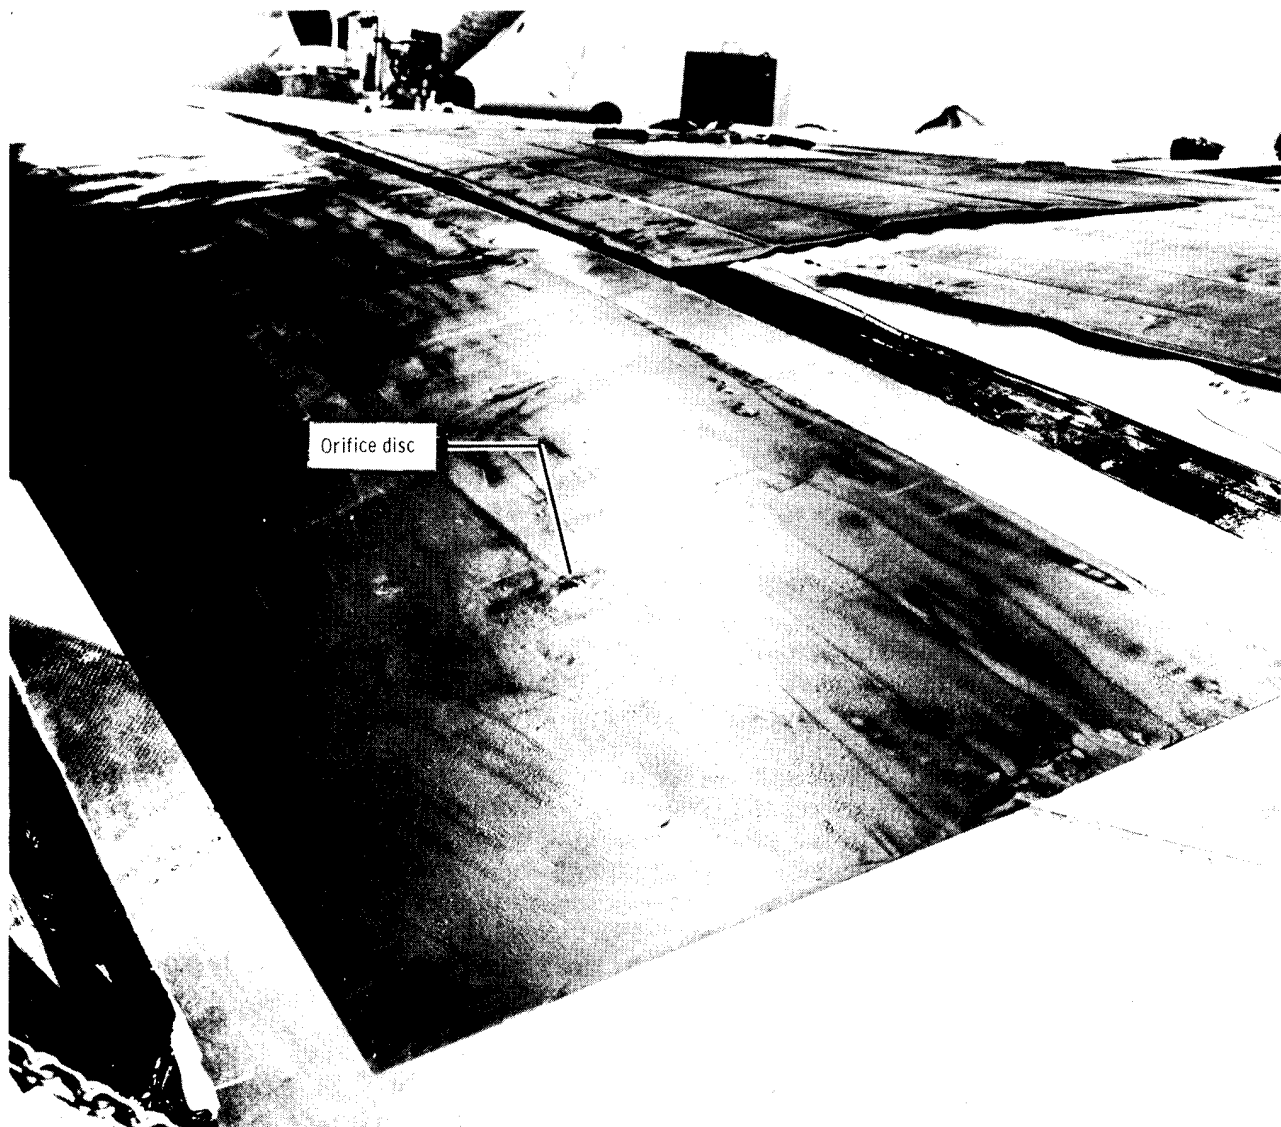
Figure 8.— Rough fairing completed.  
View from leading edge looking aft.

The coating level was kept higher than the orifice discs to insure a supply of extra material for removal in the smoothing process. After application, the RTV was continually troweled until it was firm enough that no flow could be discerned. The few air bubbles that arose during the troweling process were burst with a pointed tool. Reference marks were carefully placed at the side of the fairing strip to aid in locating the orifice discs after they were covered with Red Thunder. The marks were not needed, however, since shrinkage in the cured material clearly revealed the location of the discs. Figure 8 shows the fairing after the application had been completed. Trowel marks, waviness, the foremost orifice disc, and its tube may be detected in the photograph.
